NAWCWD TM8330

**ENGINEERING INVESTIGATION OF FAILURES OF CABLE USED  
TO TOW THE TDU-32A BANNER TARGET FROM T2C AIRCRAFT**

by Brent Meeker  
6 DEC 2000

NAVAL AIR WARFARE CENTER, WEAPONS DIVISION  
CODE 531100E

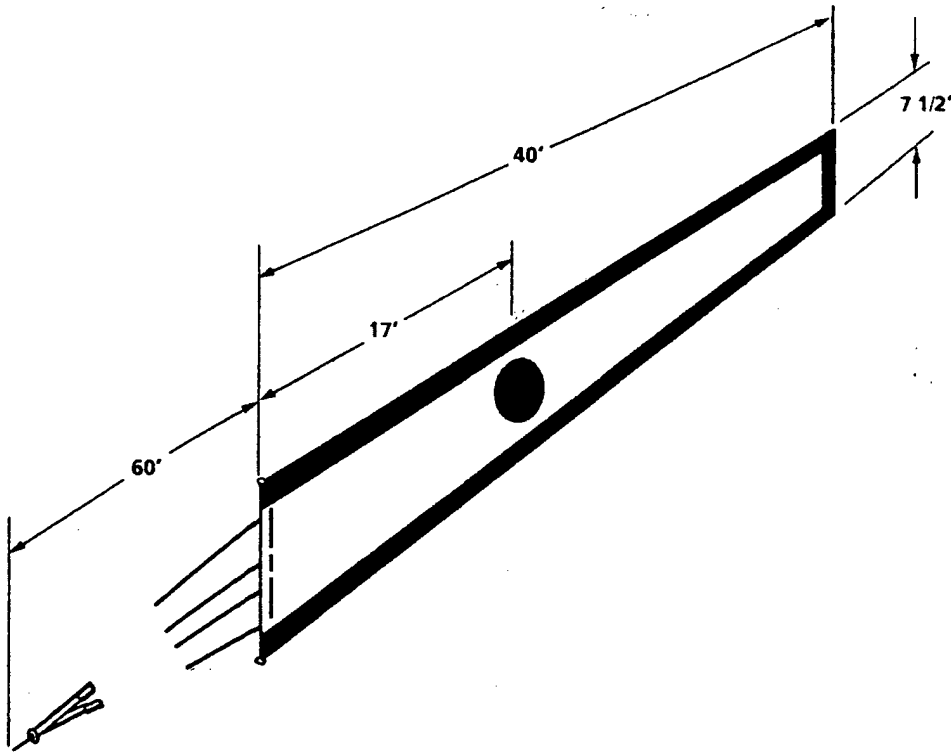
Figure 1. The TDU-32A banner.

The TDU-32A banner is described in reference [3] from which figure 1 has been excerpted. It is a panel of nylon fabric 40ft long and 7.5ft wide. At its forward end is a tow bar and bridle assembly. The bridle assembly consists of four, one inch wide nylon straps. The bridle adds another 60ft to the overall length. The total weight is 87lb. The banner can be towed at speeds up to 250KIAS.

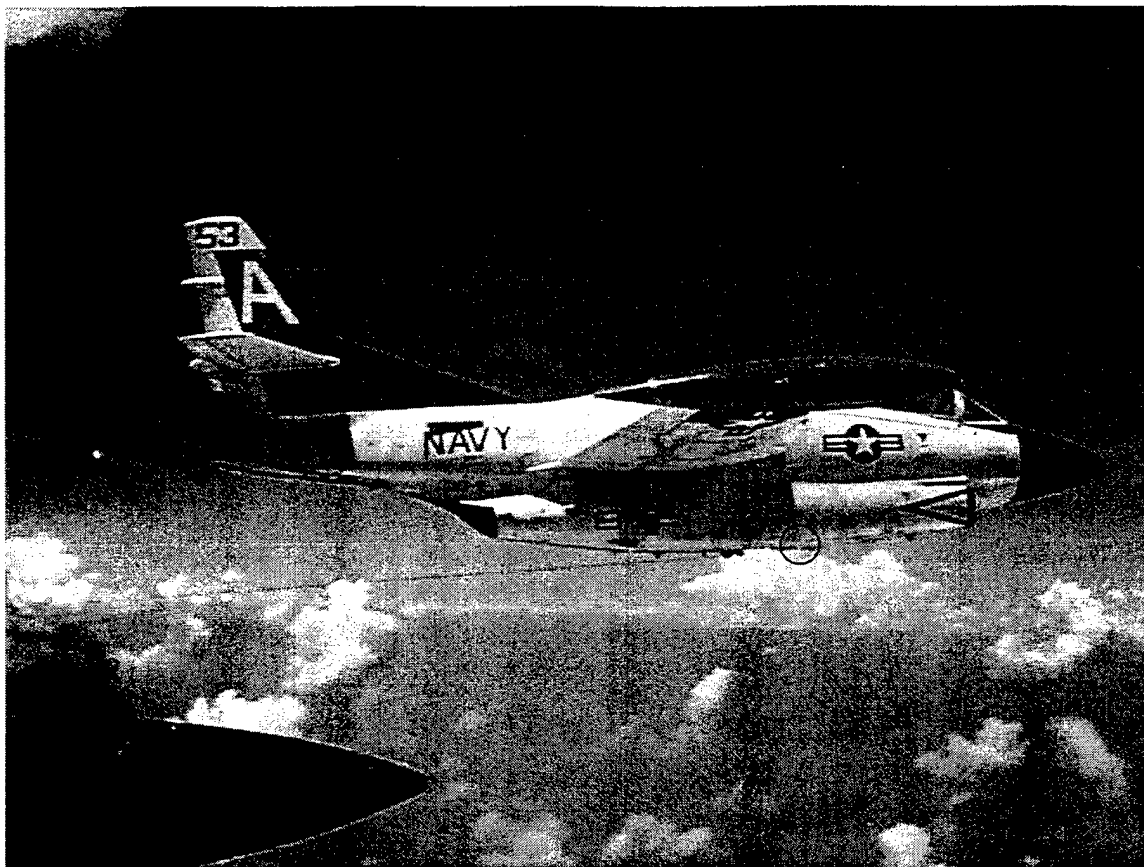
Figure 2. T2C towing a TDU-32A banner in straight and level flight at 15Kft, 200KIAS.

The TDU-32A banner is towed on 800ft of cable. VT-9 uses the North American T2C aircraft. It is the only squadron that uses this aircraft type for banner towing. The attachment point for the tow cable is on the centerline of the aircraft 13.6ft forward of the exhaust plane as shown in figure 2.

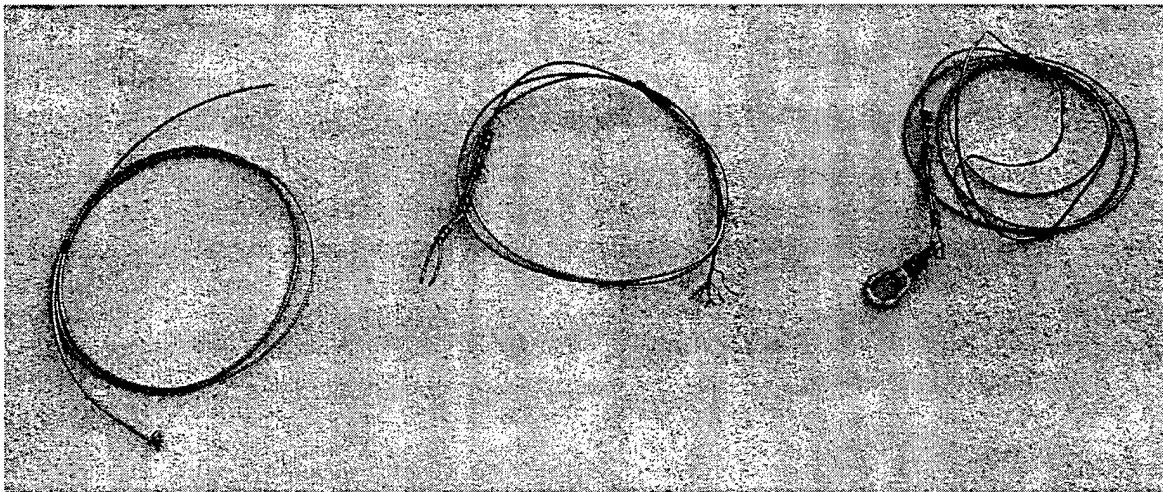
Figure 3. Sample cable pieces: an unused piece and two pieces which remained with the aircraft after in-flight failure.

Pieces of the two cables which broke in May and that returned with the aircraft were inspected. The broken pieces along with an unused piece of cable are shown in figure 3.

The first one was broken approximately 13' 10" aft of the thimble loop.

The cable was darkened, both armor and wires, for a little over two feet upstream of the break. The wires seen in the armor gaps, over the darkened section, look slightly rusty; further up they're shiny.

For approximately three feet upstream of the break, the gaps in the armor are relatively clean, so the wires can be clearly seen. Further up the cable, the gaps are filled with a dark substance which appears to be a mixture of dirt, grass, and grease. It's absence over the downstream three feet may be due to exhaust impingement.

The second broken cable (again only the aircraft end) came with the swivel. It was darkened over the last 15". The gaps between armor turns are relatively clean over the last 5'. This cable is more sharply bent over the last couple of feet; whereas the first cable was relatively straight. Overall length, not counting the swivel, is 15' 3".

The armor is more damaged than the armor of the first cable. There are a lot of impact marks on the armor over the last two feet. The armor is broken about 2" upstream of where the wires broke. There are two other breaks in the armor at 10" and 17" upstream. The greater length of this piece of cable may have caused it to flail against the aircraft more violently – hence the greater armor damage – or it may have been used on more operations.

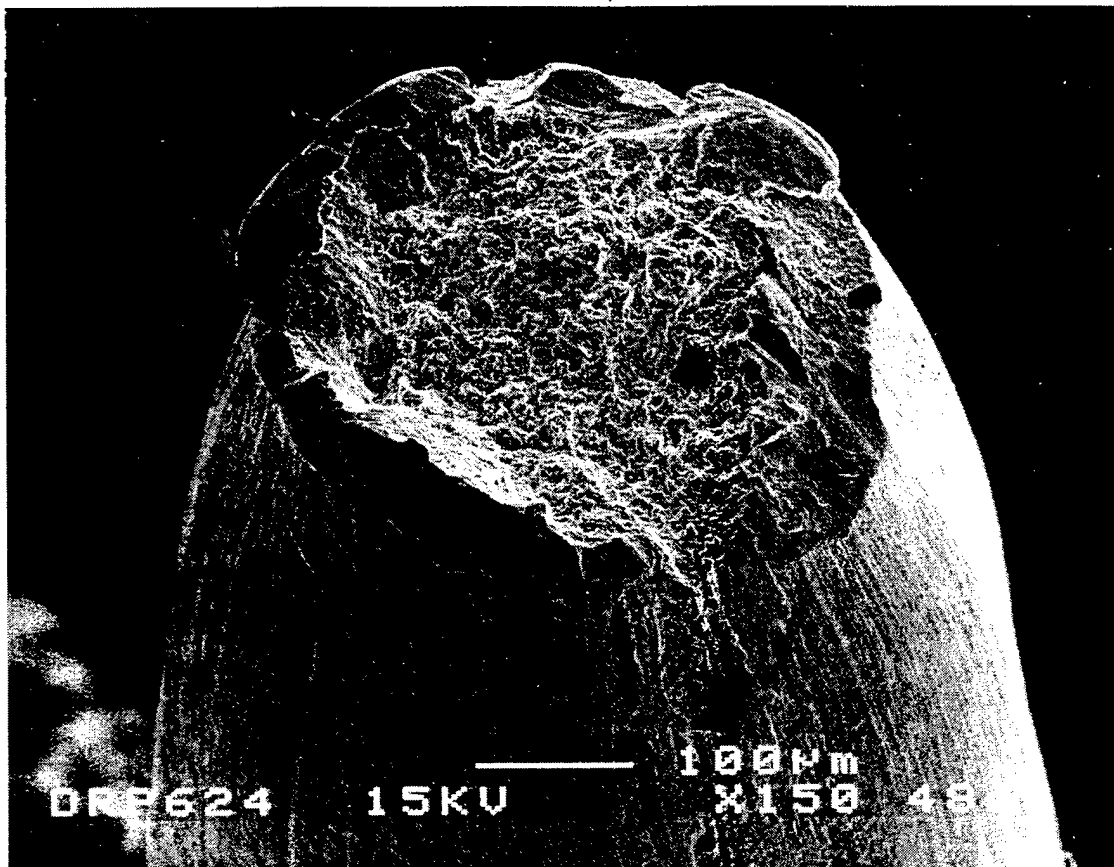
Figure 4. Photomicrograph of a broken wire from cable B.

The wires all broke at practically the same place. Except for one, the wires were still tightly wrapped – right up to the break. There is only 0.1" difference in the breakpoints from shortest to longest – and even some of this may be due to pulling out the inner wires as the outer ones broke. The individual wires show a slight reduction in diameter adjacent to the their break; indicating failure in tension as shown in figure 4.

The armor wrap broke at a point approximately 1.1" upstream of the cable break. This implies that the cable was not broken by external impact with a sharp edge; since in that case the armor would have been cut at the same point. About 0.9" of the armor wrap is unwrapped but still twisted. This probably happened after the cable broke as the load was transferred to the armor wrap until it parted.

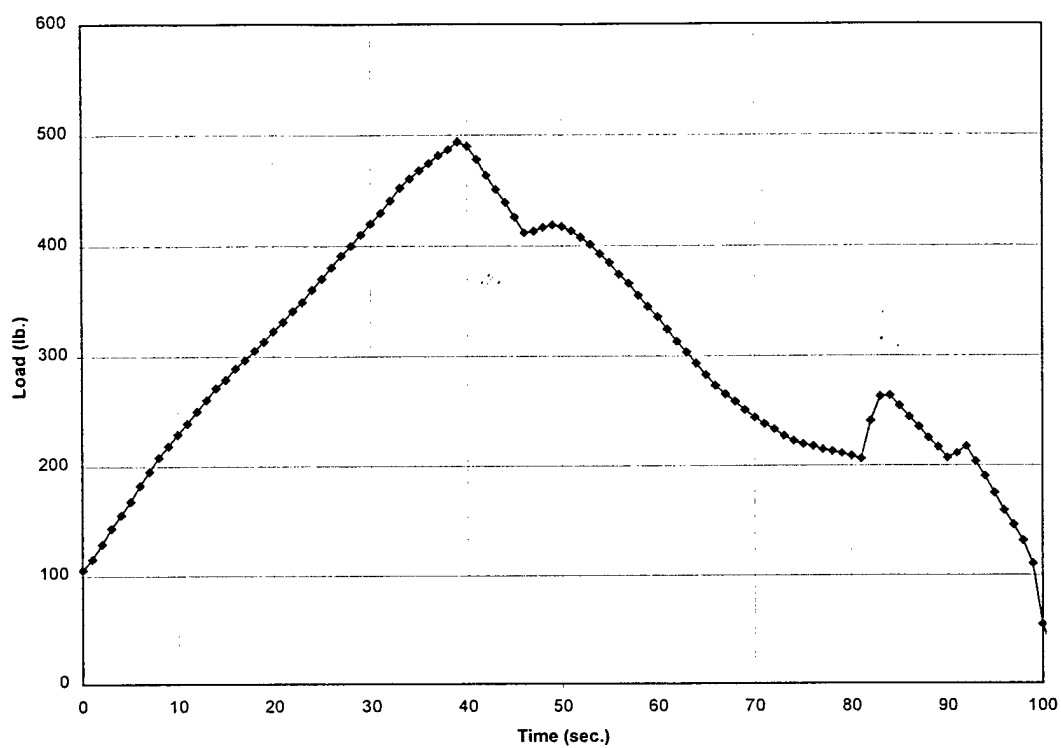
Figure 5. Load versus time for strain rate test at 1700F.

To estimate the effect of elevated temperature on the cable, a sample was tested using a constant strain-rate machine to increase the load to failure while the cable was heated to using a flame temperature of approximately 1700F. Figure 5 is a plot of load versus time as the strain was increased. The thermal time constant of the cable is around ten seconds, so the cable cross-section is near 1700F after the first twenty seconds. The cable begins to fail at a tensile load of approximately 500lb. The tensile load in flight is discussed below in the section on analysis. It is shown that the load can considerably exceed 500lb during a turn.

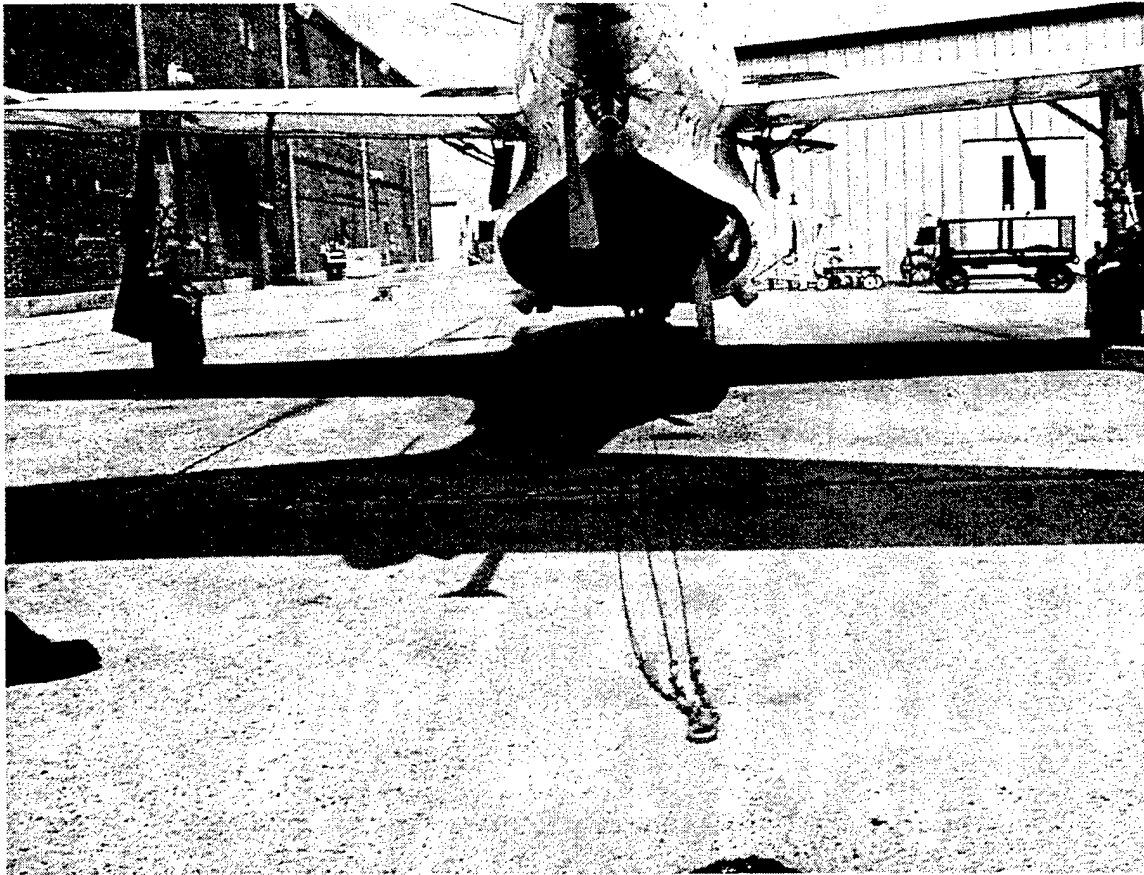
Figure 7. T2C engine exhaust and proposed three-cable leader.

The configuration of the T2C exhaust is shown in figure 7. The exit nozzles are approximately 1.2ft in diameter. They are about 2.2ft apart, center-to-center. Also seen in this photo is a three cable leader proposed by Jerry Fox, SSSI Meridian site manager, as a possible solution to the cable breakage.

Another possible corrective action, suggested by Jerry Fox and shown in figure 7, is to provide multiple cables in the section of cable that may come into the exhaust. As shown in the figure, the cables would inevitably be of slight different lengths so that the load would not be shared equally; rather one would carry almost all of the load while the other two were lightly loaded. If a maneuver brought the cables into the exhaust the heavily loaded cable would fail first. It is possible that the other two would also fail in the same incident. If all three were in the exhaust together they would all be heated and weakened. When the heavily loaded cable failed there would be a sudden transfer of load to the next longest cable. A suddenly applied load in an elastic system results in twice the stress of the same load gradually applied. Hence the next longest cable might very well fail and then also the third and last cable. A more complex joining of the multiple cables to the single cable, such as using a wiffle tree, could ensure the load was evenly distributed among them.

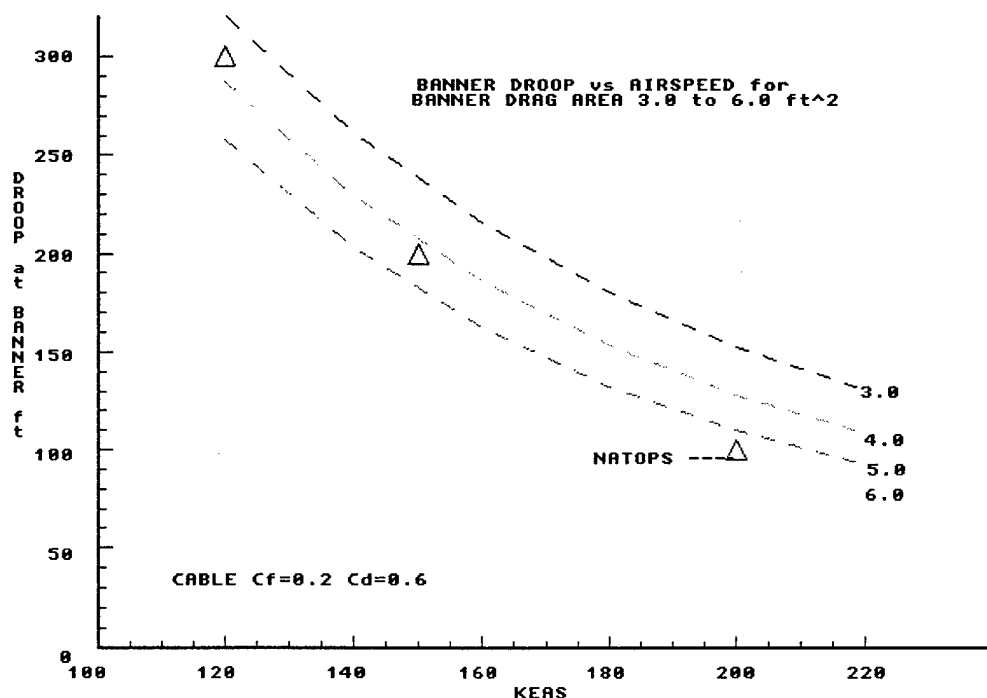
Figure 8. Comparison of droop predicted by steady-state analysis and tabulated NATOPS values.

The simpler of these two determined only the steady-state, equilibrium shape of the cable for straight and level flight or for a level turn at a constant rate. As shown in Appendix B the assumption of steady-state reduces the problem of determining the cables towed shape to the integration of a set of ordinary differential equations. The greatest uncertainty in application of these equations is the drag of the banner. This was estimated by matching the droop tabulated in the NATOPS as shown in figure 8. No realistic combination of banner and cable aerodynamic parameters could be found to match all three NATOPS data points, but a banner drag area of  $4.0\text{ft}^2$  matched at 150KIAS and was close at the other two speeds.

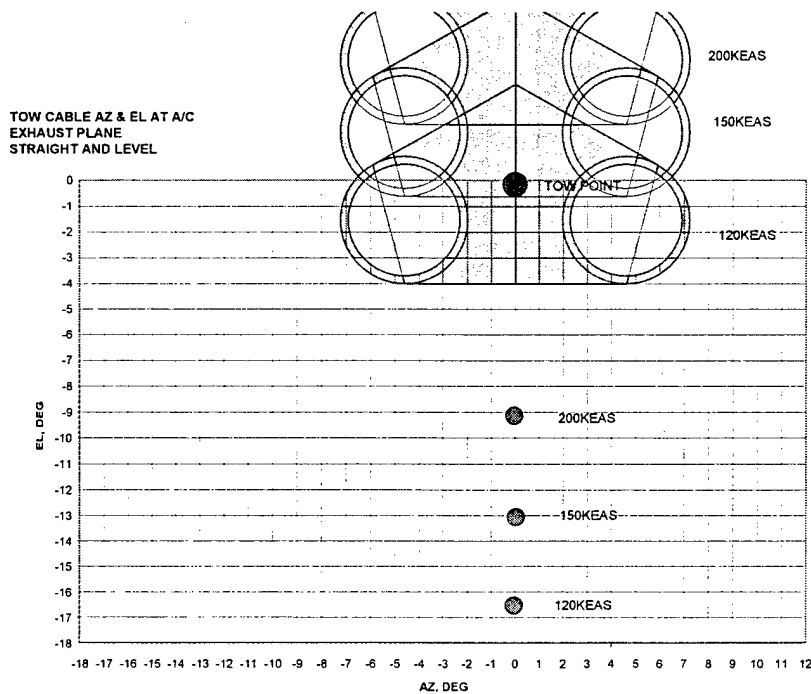
Figure 9. Cable and exhaust nozzle positions at the exhaust plane for straight and level flight at various airspeeds.

into account the angle-of-attack of the aircraft. For straight and level flight this is illustrated in figure 9. At the lower speeds the angle-of-attack is greater and so the cable droops further, but also the exhausts are lower relative to the tow point. In a turn, the angle-of-attack must increase further to achieve the lateral acceleration and so the exhaust moves outward relative to the tow point. At the same time the tow cables intersection with the exhaust plane moves inward toward the center of the circle because the lagging banner causes the cable to cut across the circle as a secant.

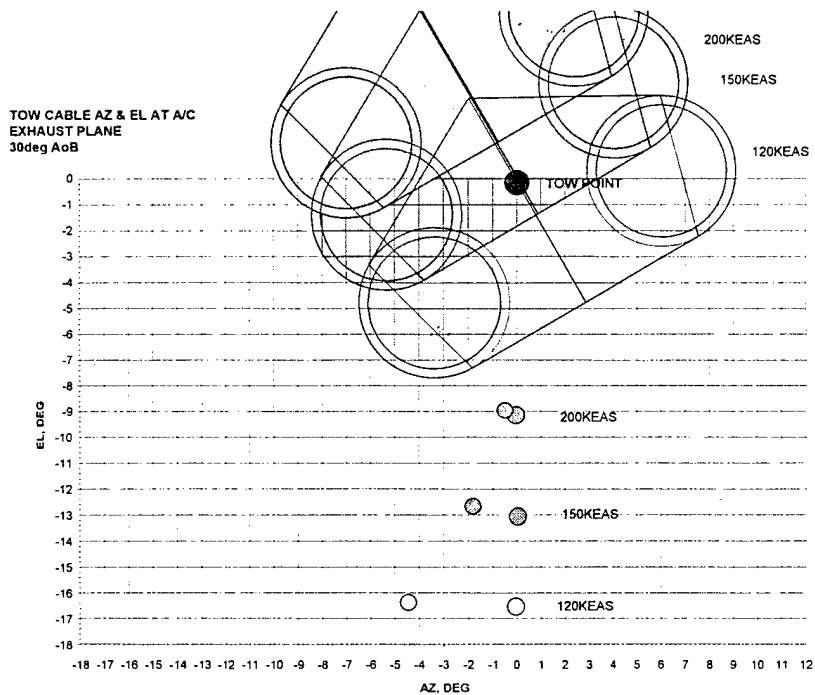
Figure 10. Steady-state position of the cable in the exhaust plane for level 30<sup>0</sup> AoB turns.

The greater tension due to the centripetal acceleration also causes the banner to droop less so the cable is higher at the exhaust plane. The predicted cable steady state position is shown for  $30^\circ$  AoB in figure 10 and  $60^\circ$  AoB in figure 11. The straight and level cable position is also shown for reference.

Although the analysis is only for steady-state, comparing the location of the cable for turn and straight and level gives a rough estimate of the dynamics for a very smoothly initiated turn. In this case only the lowest dynamic mode of the cable motion will be excited and the motion will be approximately harmonic about the equilibrium position. The amplitude would be that which causes the motion to pass through the initial condition, i.e. the straight and level point. Since the lateral and vertical motion will have different periods, the locus of the cable will be within an ellipse as shown in figure 11 for the 200KEAS case. This indicates that the cable could come near the exhaust, but it does not predict that it would actually enter the exhaust stream.

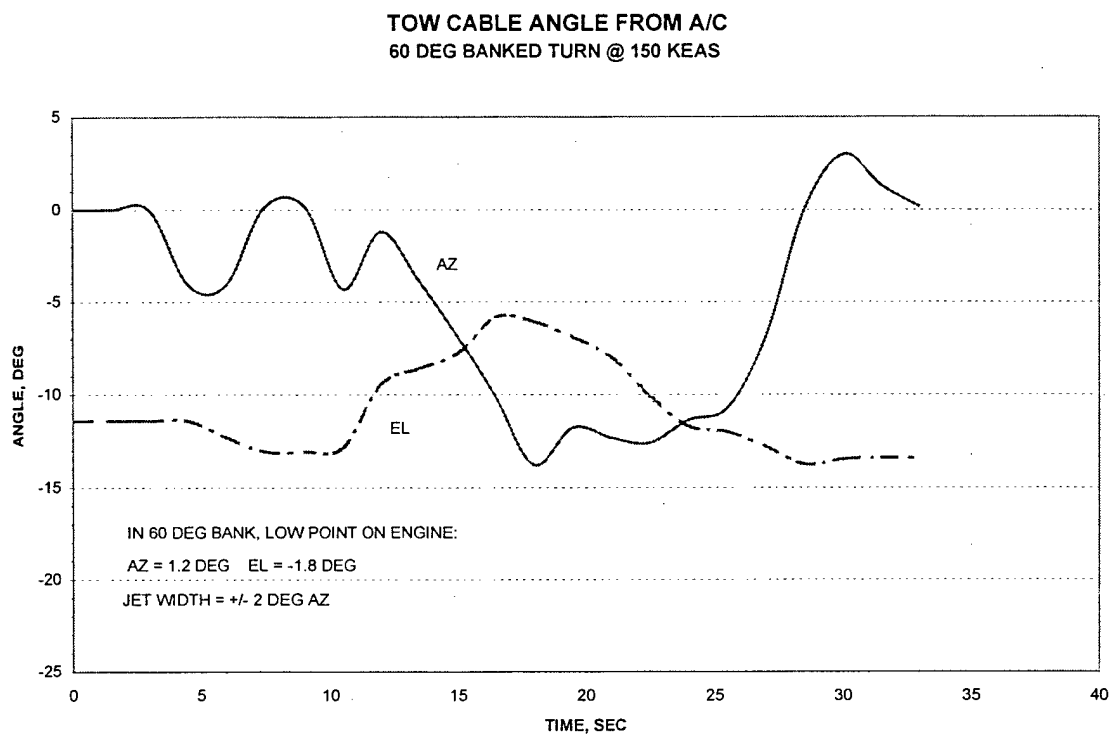
Figure 18. Cable angle at the two point relative to the tow point velocity vector versus time.

Plotting the same data in terms of cable angle versus time shows, as in figure 18, shows that the systems natural frequency (lowest mode) is about 6seconds. This mode is excited in the CBAS simulation because an abrupt turn was assumed. This mode produces a 'crack-the-whip' effect so that the peak tensile load almost doubles – from 190lb straight and level to 345lb just after initiating the turn, as shown in figure 19. However, these load values are not credible since the steady-state load, before entering the turn should have been 380lb, as noted in the Appendix. These inconsistencies in the CBAS analysis make all of the results suspect.

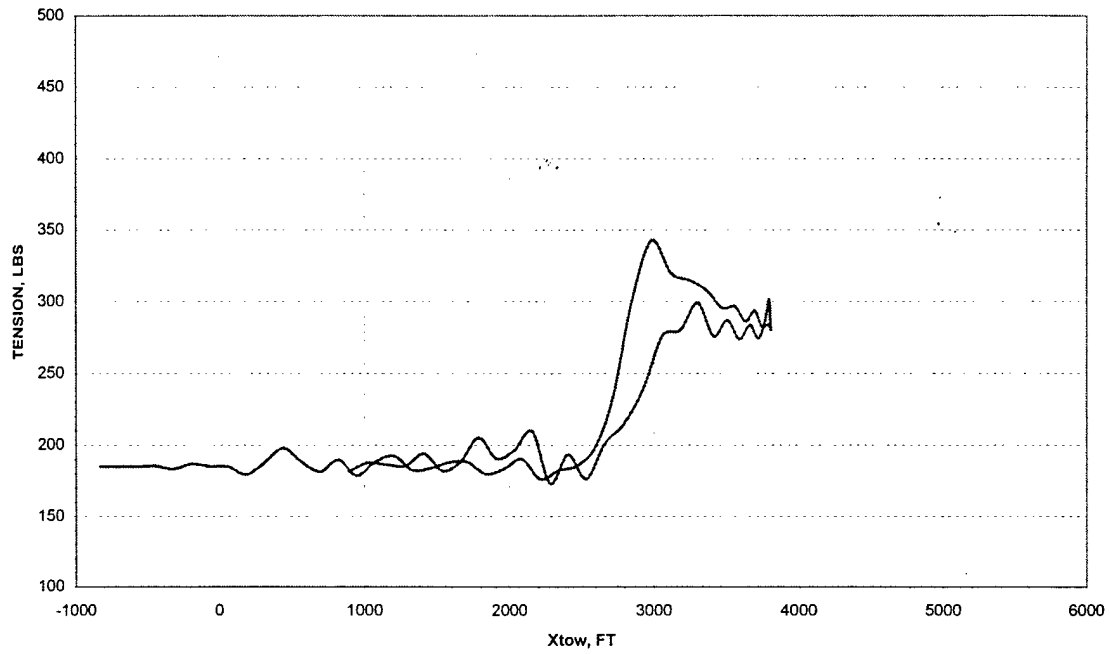
Figure 19.. Tow cable tension at the tow point as a function of down-range position.

CABLE TENSION AT A/C IN TURN  
150 KEAS, 60 DEG BANKED TURN

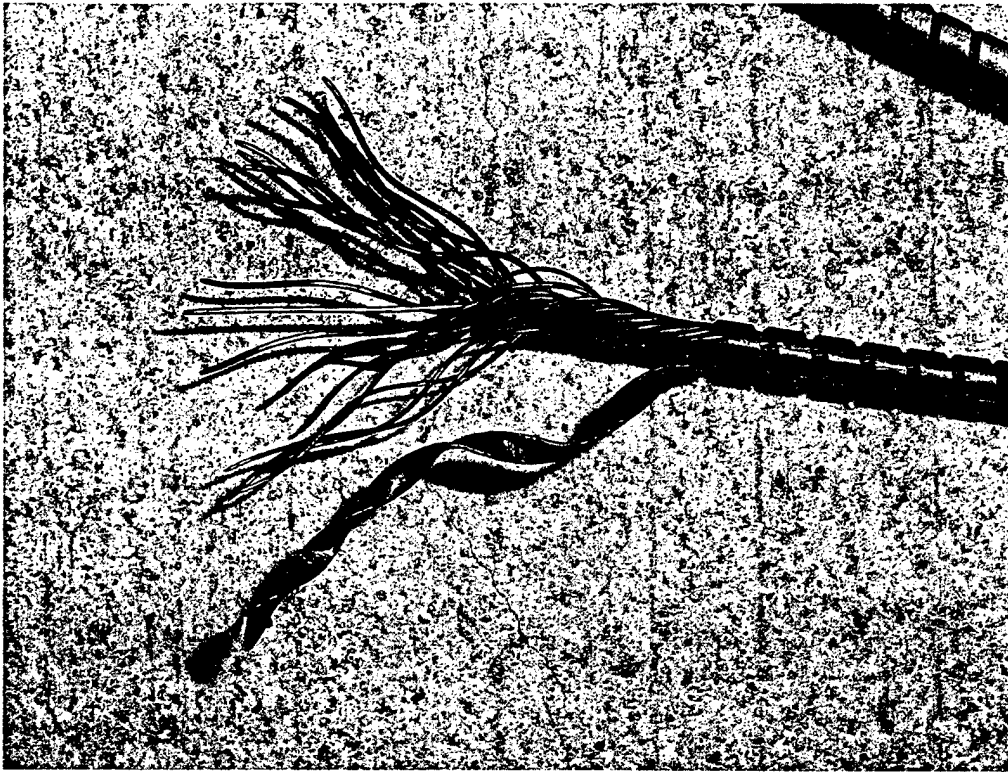
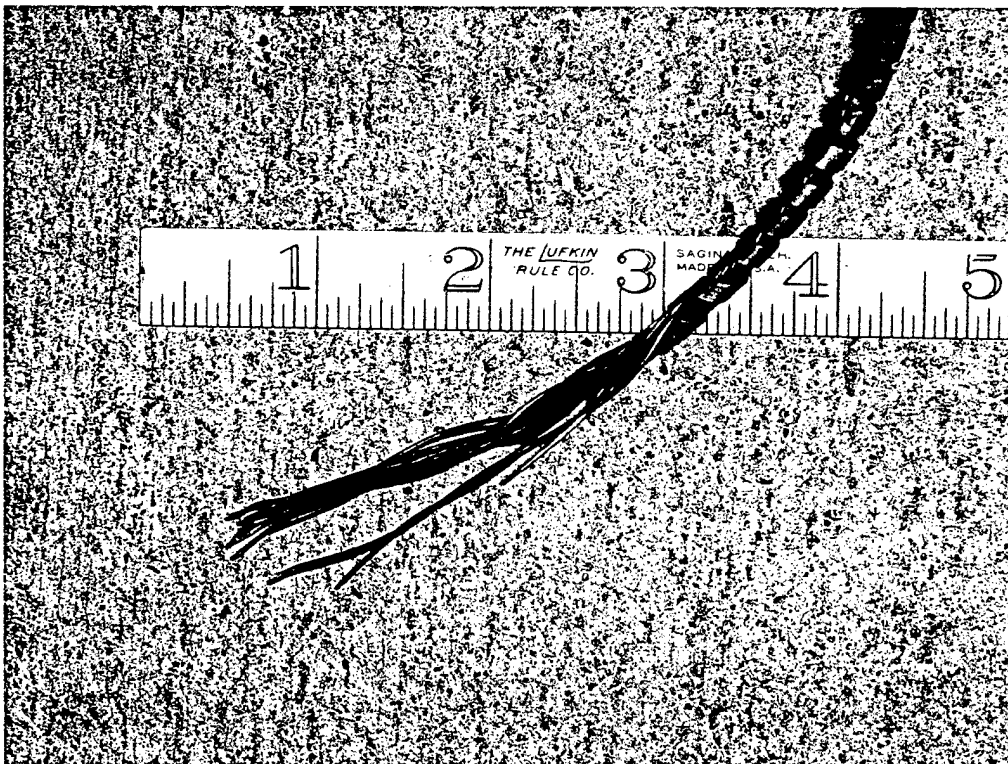
Figure 4. Failure ends of cable B (a), and cable C (b)

Higher magnification of the surface by scanning electron microscopy (SEM) confirmed necking, and revealed cup and cone fractures typical of failure by tension overload. Figures 5, 6, and 7 consist of micrographs of large and small outer layer wires and an inner layer wire from cable B. Higher magnification of the fracture surface as in Figure 7b. revealed corrosion too severe for removal and further feature or fracture mechanism identification.

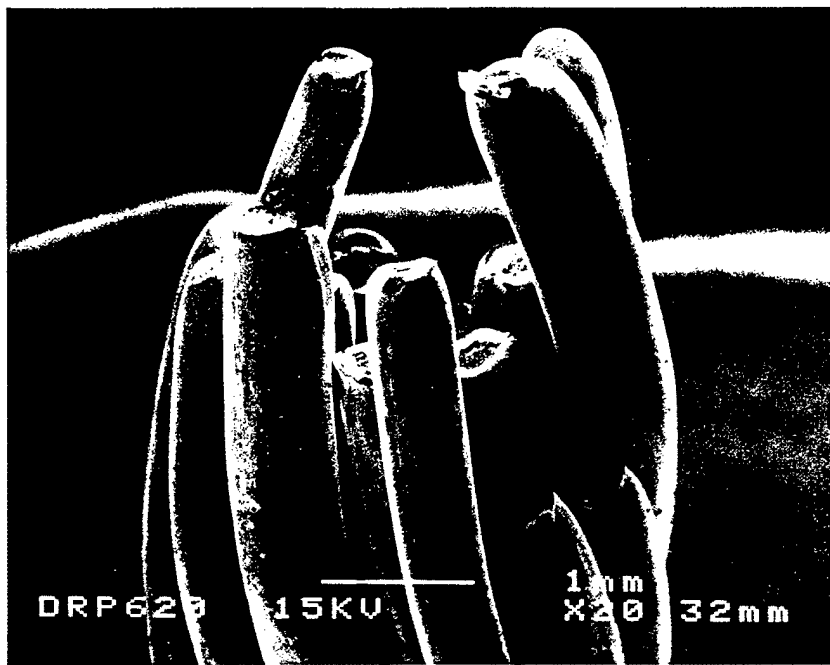
Figure 8. Fractured wires from cable A tensile test.

For comparison, fractographs of the wire fractures from the tensile tests discussed below are presented in figures 8, 9.

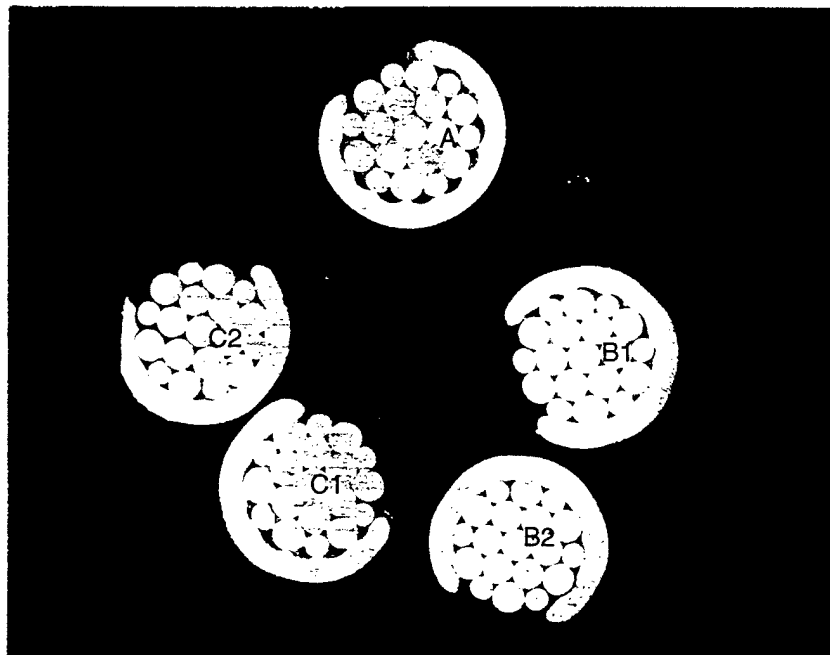
Figure 12. Cable cross sections for metallography and hardness tests.

Microhardness test were conducted with a Knoop indenter and 500 grams-force on five cross sections of the three cables. The five cross sections are shown in Figure 10. The results are presented in Table 1 and Table 2.

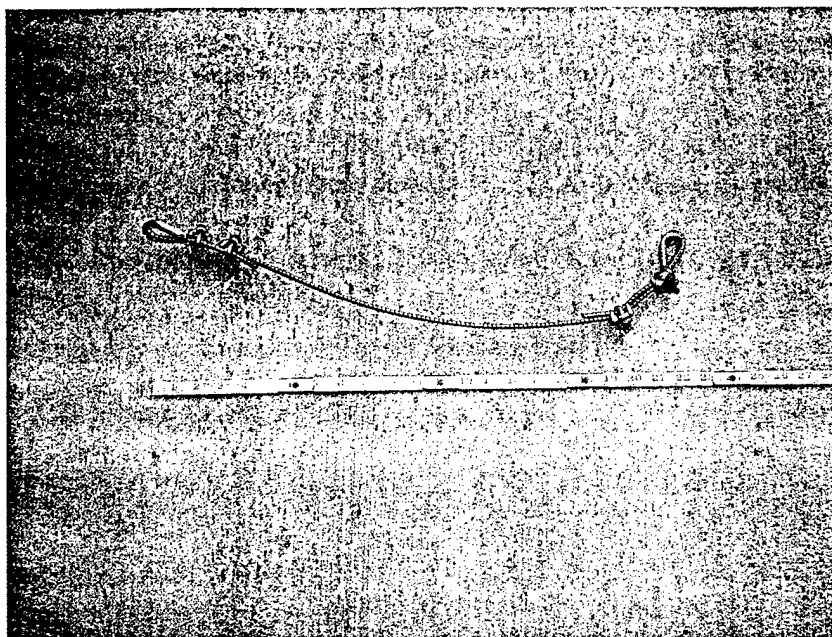
Figure 14. Tensile test assemble.

Test section were assembled with thimbles and clips as depicted in Figure 14 to give a test length of approximately 24 inches.

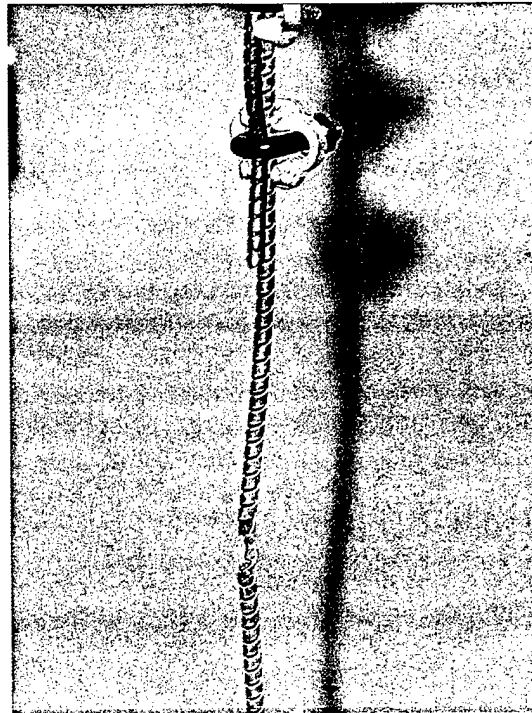
(b)

The cable broke at a maximum load of 2,170 lb. (Figure 16 b).

Figure 16. Heated cable residue (a), and tensile test break (b).

4.2.1 Residual heating affect. A section of unused cable was placed in a muffle oven at a temperature of 1700 °F for approximately 15 seconds. The cable was allowed to cool to ambient temperature, fitted with thimbles and clips as in previous tests and then pulled to failure. Figure 16a shows the cable subsequent to heating. While in the oven the lubricant on the cable ignited, leaving a residue similar in appearance to that observed at the failure ends of cables B and C.

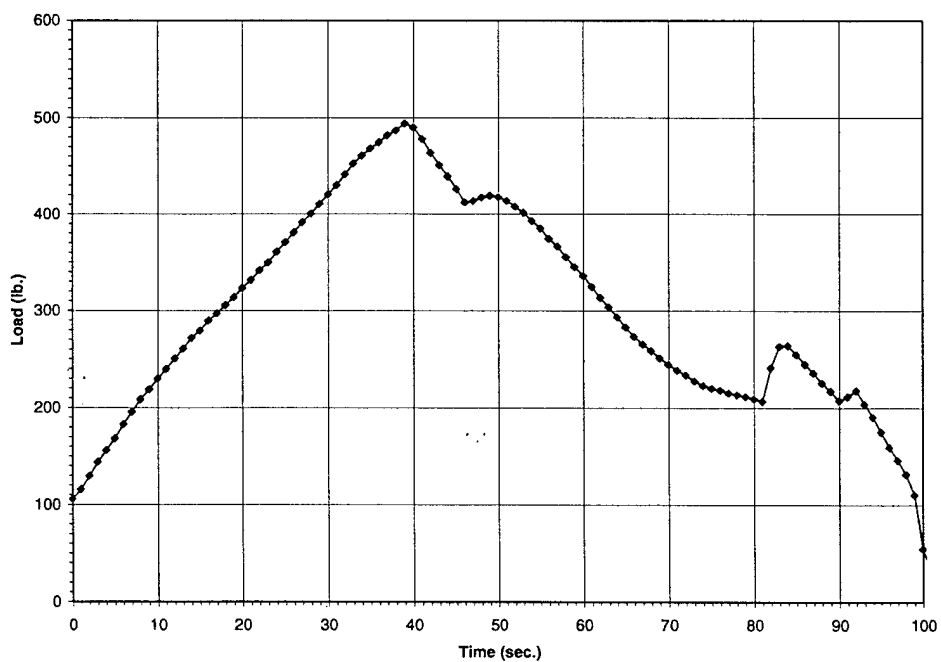
Figure 18. Load at elevated temperature.

4.2.2 Load at elevated temperature. A section of unused cable was loaded while being heated. Figure 17 depicts the test configuration. A bunsen burner was adjusted so that the cable was at a position in the flame of where the measured temperature was approximately 1700 °F (+/- 100 °F). The Instron tensile test machine employed for the the test is a constant strain rate machine. Therefore the load applied was not constant, but varied as the strain rate was adjusted between 1.0 and 0.1 in. per min, as the test progressed. Figure 18 shows the load with time. A maximum load of 494 lb. was attained after approximately 39 seconds.

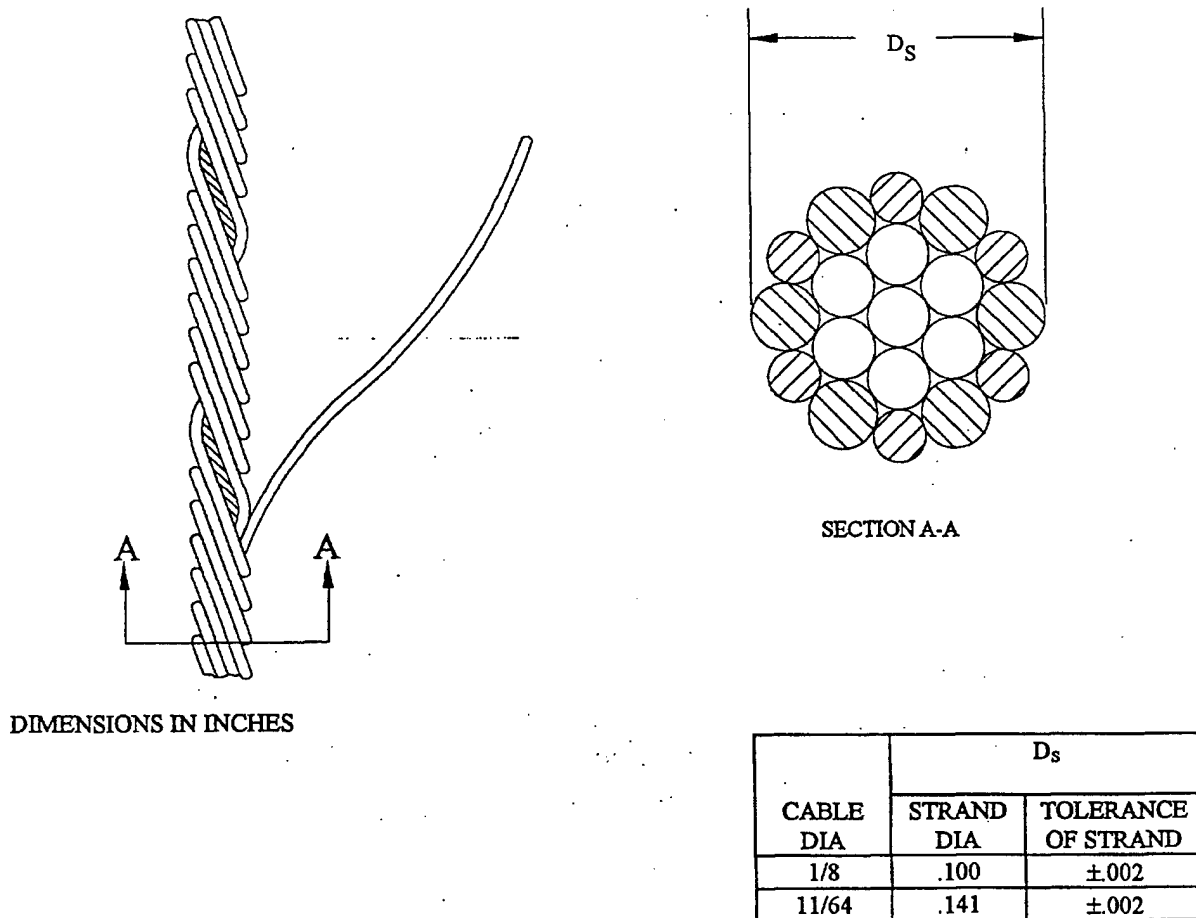
FIGURE 1. Strand Construction

3.4.3 Strand construction. The strand shall be a Warrington design conforming to Figure 1 and having 19 individual wires. Six wires shall be laid around a central core wire with a left-hand lay (see 6.3.4), and 12 wires shall be laid around the first operation in a left-hand lay. The wires shall have a pitch (see 6.3.5) of not more than 8 nor less than 7 times the strand diameter. The individual wires of the strand shall have three different diameter sizes. The strand diameter is shown on Figure 1.

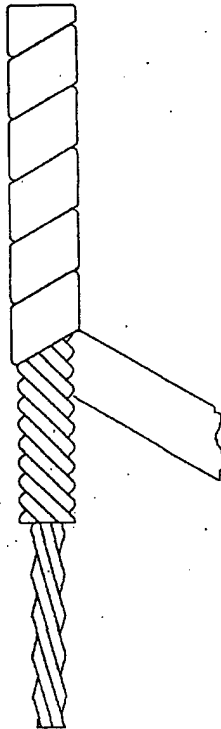
FIGURE 2. Cable Exploded

3.4.6 Armoring. The armor shall consist of one flat steel wire wrapped spirally around the strand in a clockwise direction as shown on Figure 2. The spacing between the spirally wound armor flat wire shall be such as to provide a spacing after swage as required in 3.4.7.

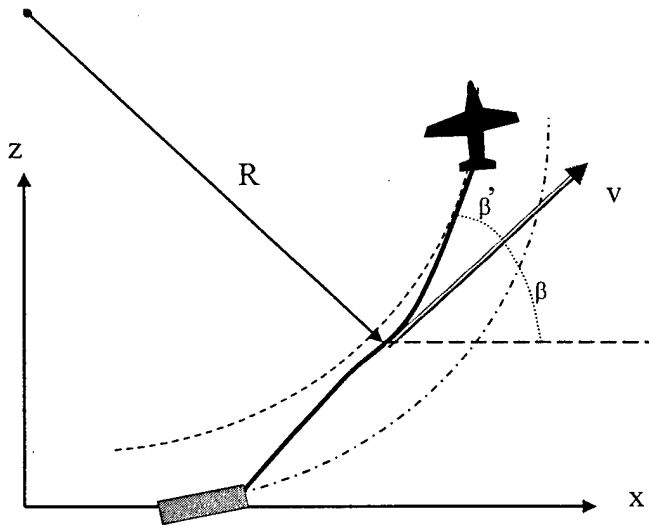
Figure A1. Aircraft and banner paths for a steady turn.

If the towing aircraft executes a steady level turn, the tow cable will, after initial transient motions damp out, will assume a certain equilibrium shape in which the tensile, centrifugal, aerodynamic, and gravitational forces balance out. Straight and level flight may be regarded as a special case in which the radius of turn is very large. Because the centrifugal force will cause the banner to follow a curve of greater radius than that of the aircraft, the radius at a point on the cable distance  $S$  from the banner varies with  $S$ . Since the configuration is a steady-state one the airspeed at any point on the cable is also varies directly as the radius. The relationship is shown in figure A1.

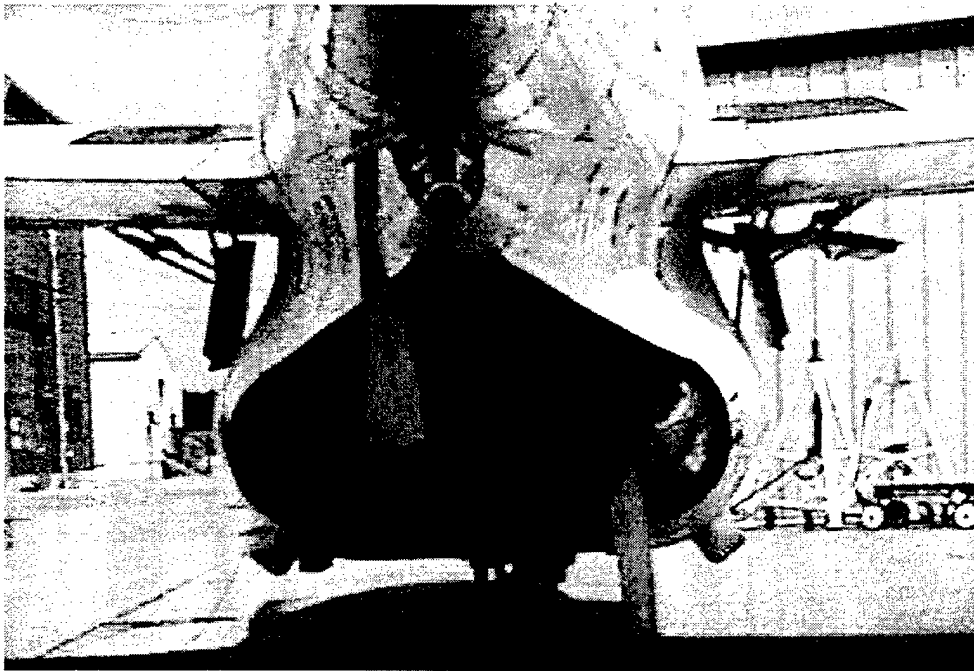
The T2C has twin engines mounted low on the fuselage as shown in figure 1. The engines are approximately 2.2ft apart, center-to-center. Each exhaust has a diameter of approximately 1.1ft.

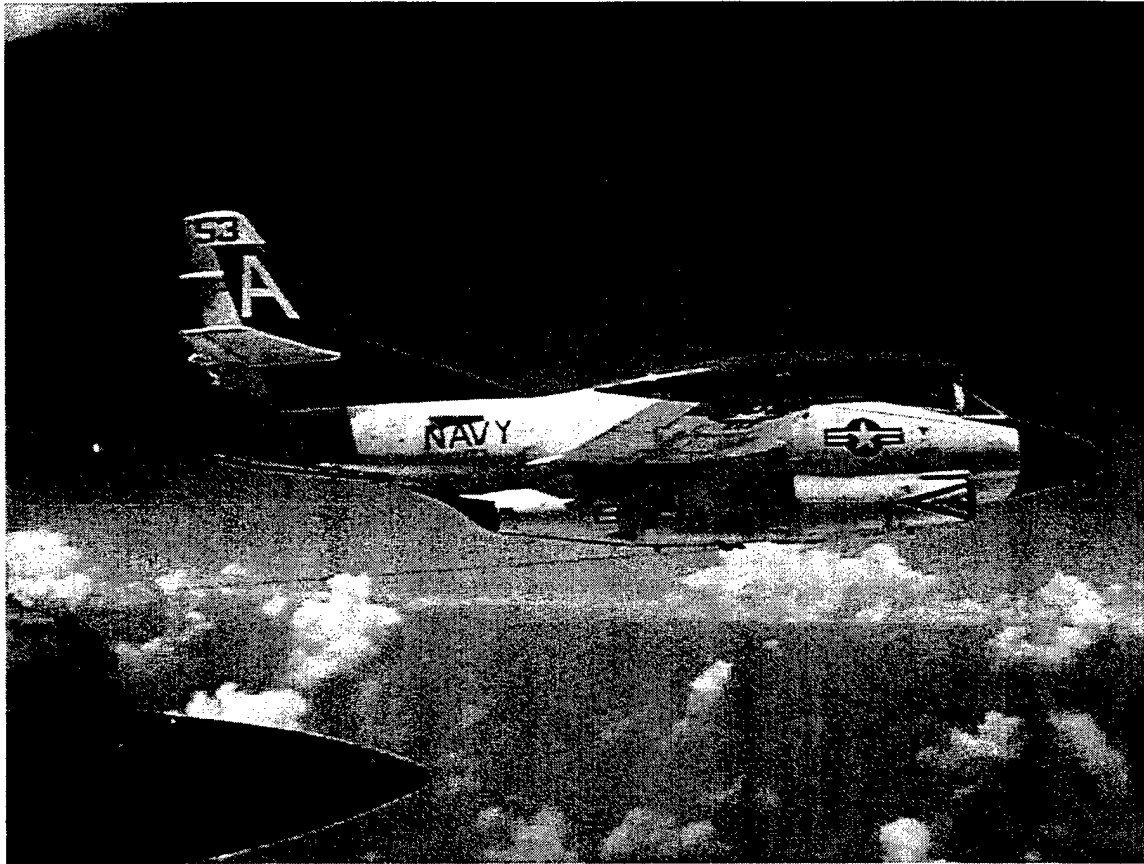
Scaling from figure 2, the tow point is 13.3ft forward of the exhaust on the center-line of the belly. This photograph was taken a 200KEAS in straight and level flight. At this flight condition, the bottom of the exhaust opening is seen to be 0.58ft above the tow point.
